ENVIRONMENTAL
HEALTH SERVICESMEMORANDUM

SUBJECT: Radiation Survey of Sooner Dial

On April 24, 1990, Gary Ammon and I traveled to Clinton for the purpose of conducting a radiation survey of the building, land, and rubble which was associated with the Sooner Dial Facility. The present land owner, Ron Grubb, was contacted (405-323-6400), and we received his permission to survey the site. We were also assisted by our local sanitarian, Terry Thiesson.

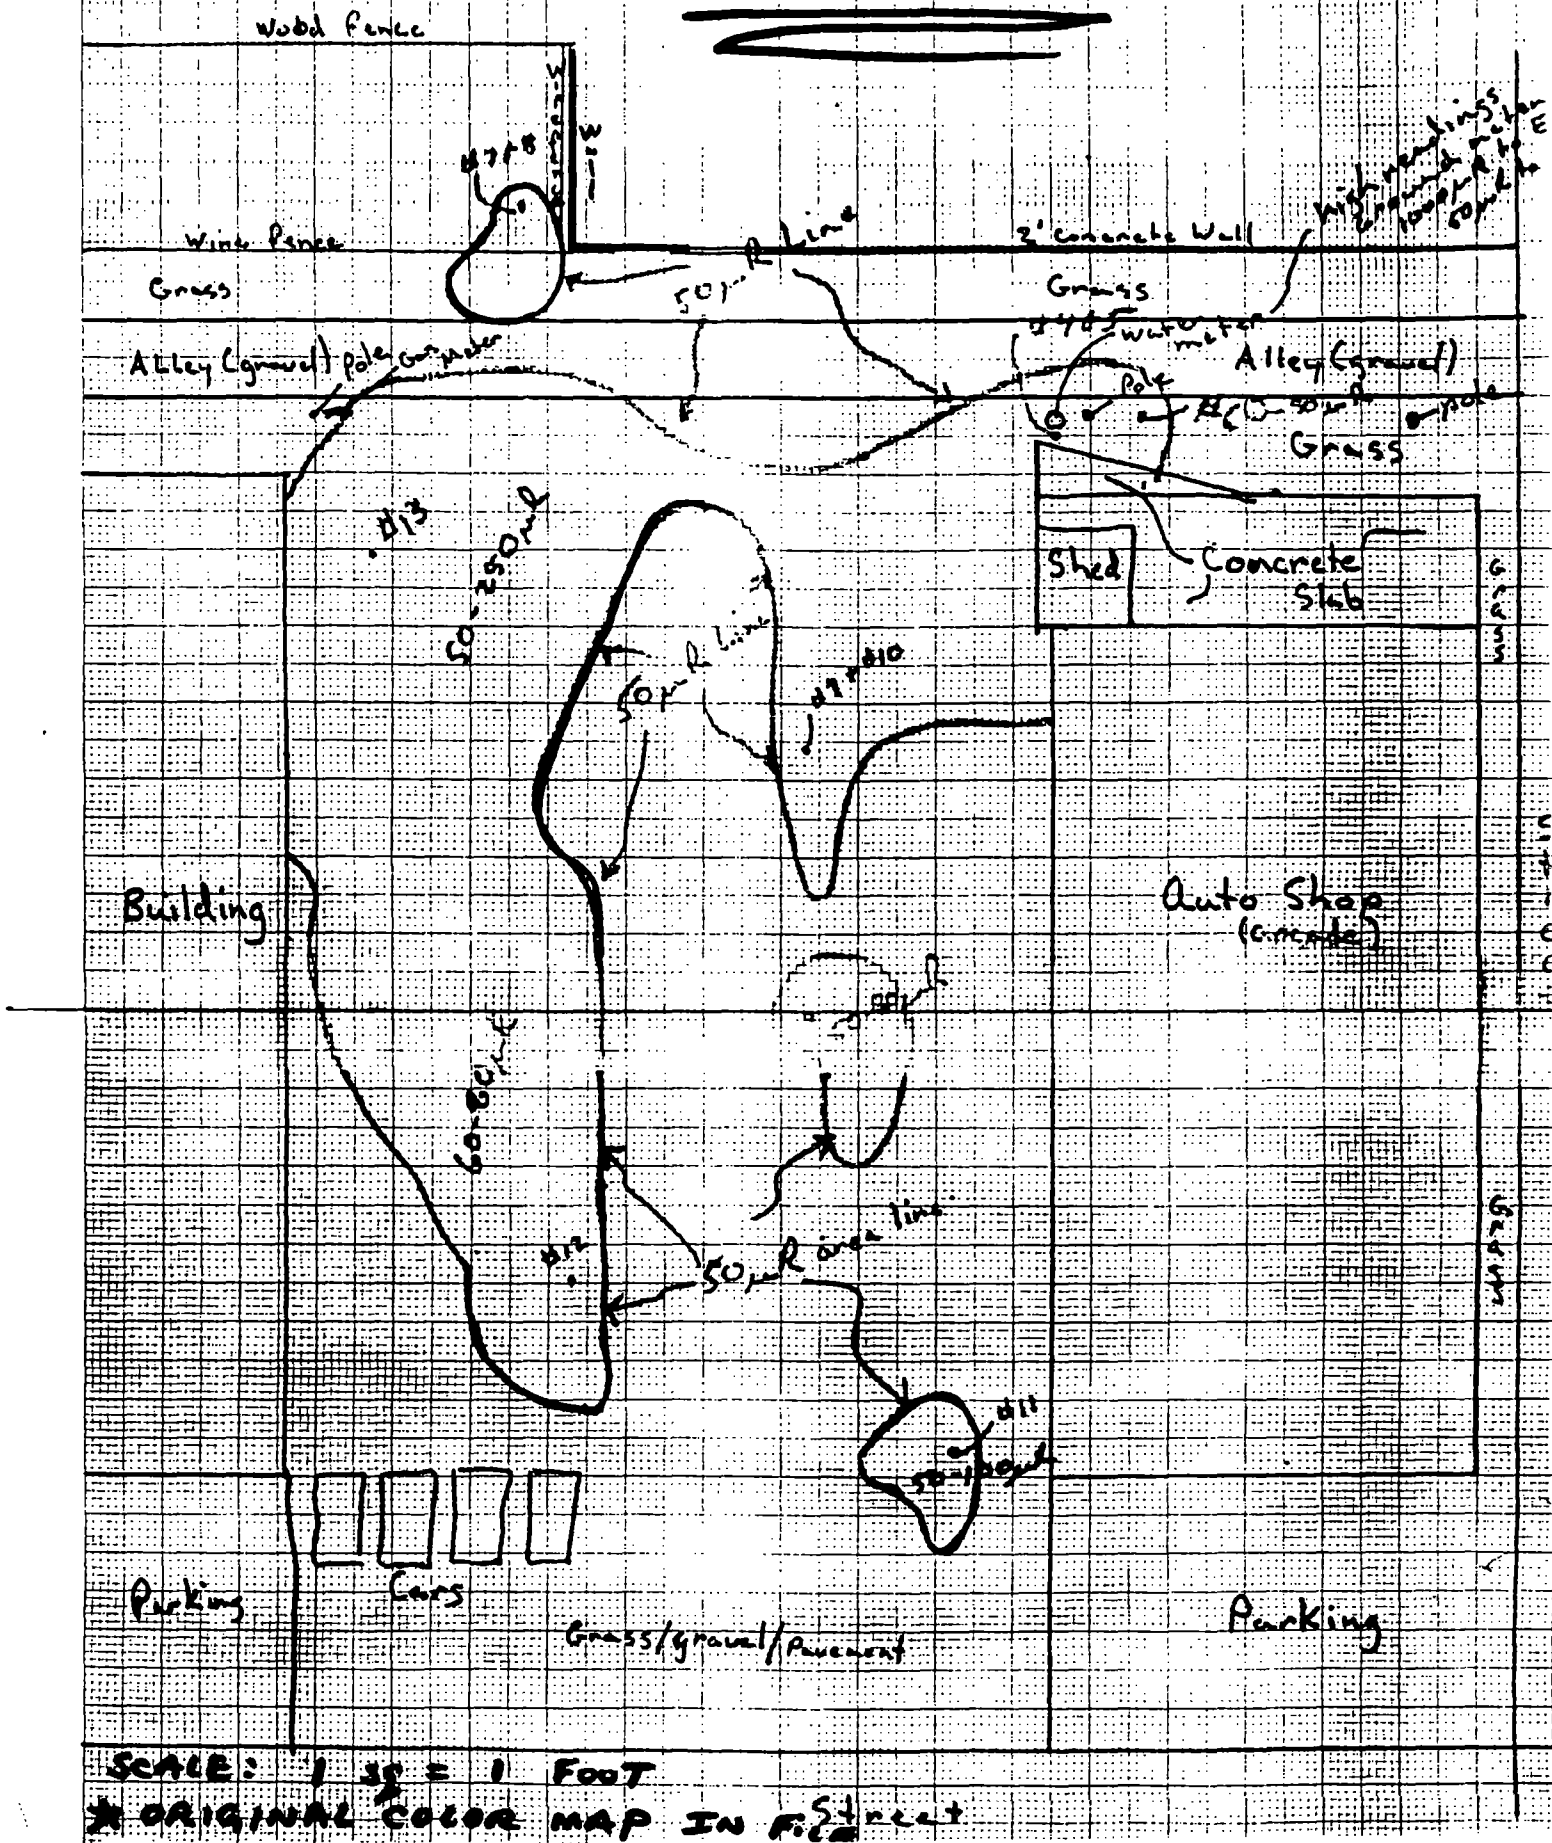
Attachment 1

A radiation survey was performed at all locations utilizing a Ludlum Micro-R Meter. Gamma readings in excess of 50 micro-R per hour (approximately 7 to 8 times background) were noted and those areas delineated on the map. In addition, soil samples were taken for further analysis. Sample numbers and locations are also noted on the accompanying map.

A building formerly located at the rear of the auto body shop had been removed in late 1984, and the rubble transported to the dump area previously mentioned. There appears to be concrete in areas of the lot 4 - 6 inches below the surface. The following sample locations (noted on the map) and readings are associated with this lot and the adjacent areas:

<u>Sample Location</u>	<u>Gamma Reading</u>	<u>Soil Depth</u>	<u>Activity/Gram</u>
4	1000 Micro R	0 - 6 In	571
5	1000 Micro R	6 - 12 In	1003
6	50 Micro R	0 - 4 In	83
7	50 Micro R	0 - 6 In	71
8	50 Micro R	6 - 12 In	1002
9	50 Micro R	0 - 6 In	176
10	50 Micro R	6 - 12 In	102
11	100 Micro R	0 - 6 In	121
12	100 Micro R	0 - 6 In	31
13	250 Micro R	0 - 6 In	412
